Winter 2009-10

**The Navy & Marine Corps
Aviation Maintenance Safety Magazine**
WINTER 2009-10, Volume 49 No. 1

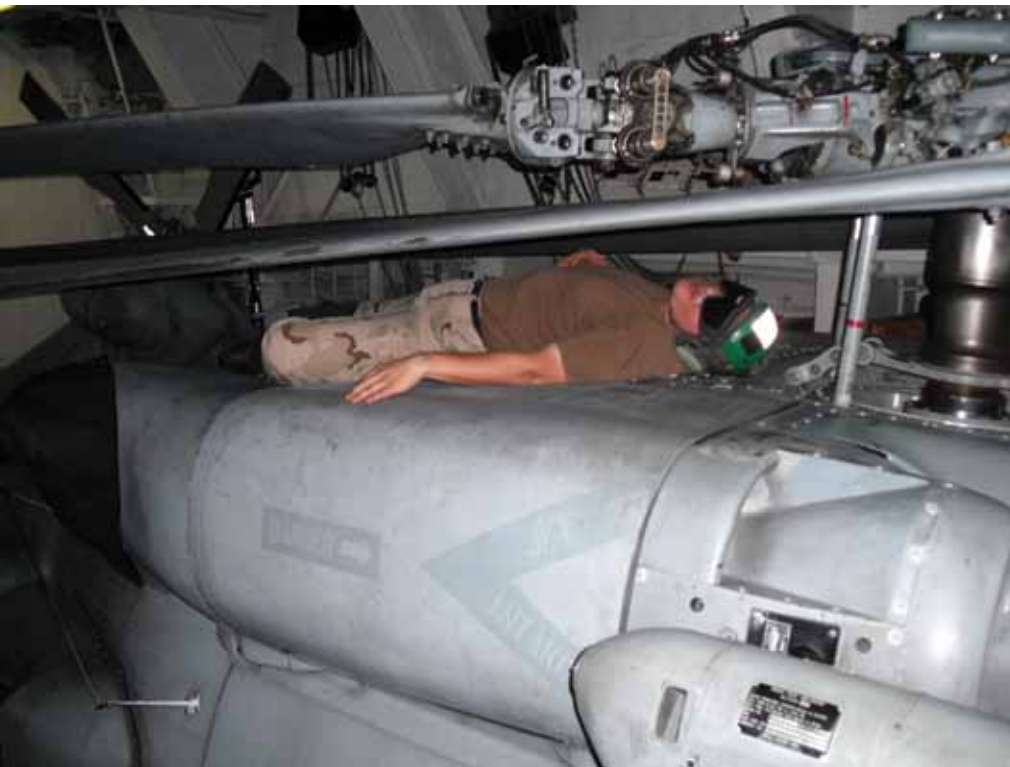
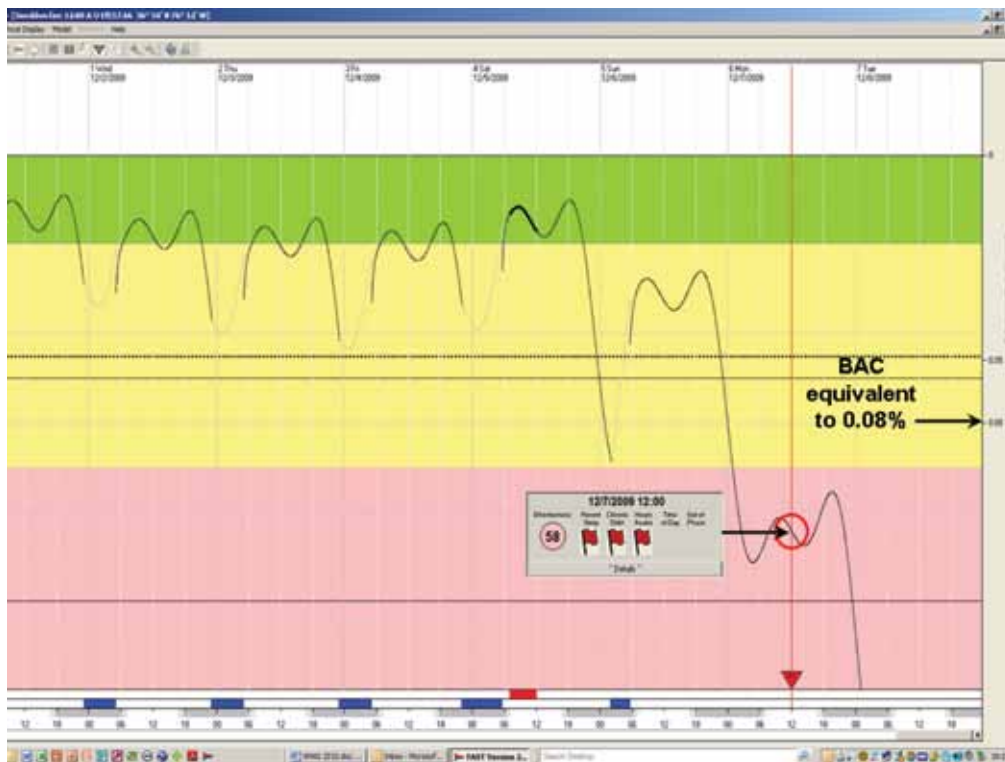
aircraft, we know a lot about how people respond to lack of sleep. The enclosed figure is a theoretic analysis of his predicted level of effectiveness at the time of his incident, using the Fatigue Avoidance Scheduling Tool (FAST), a computer program developed to predict performance, based on sleep and duty cycles.

For someone who got only three hours of sleep in the previous 48 hours, he would be predicted to be at about 58 percent of his baseline performance level when well-rested, with three red flags showing (in the figure) because of chronic sleep debt, lack of recent sleep, and being continuously awake for more than 16 hours.

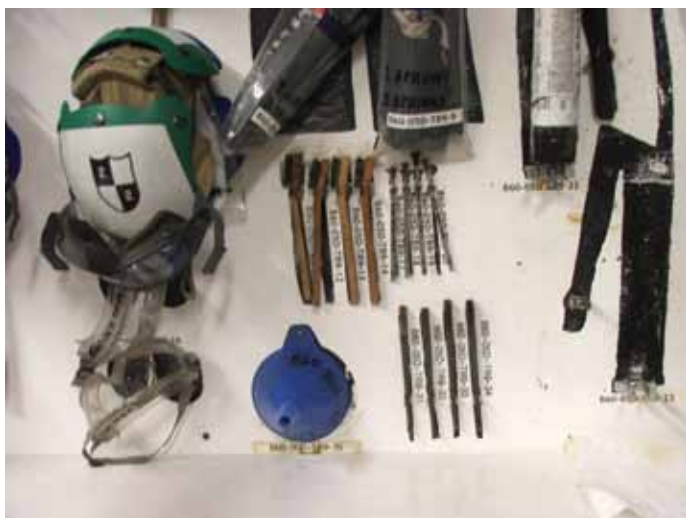
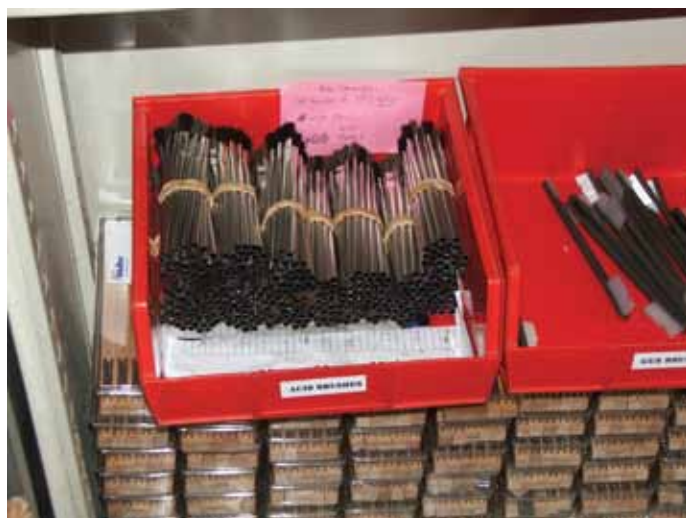
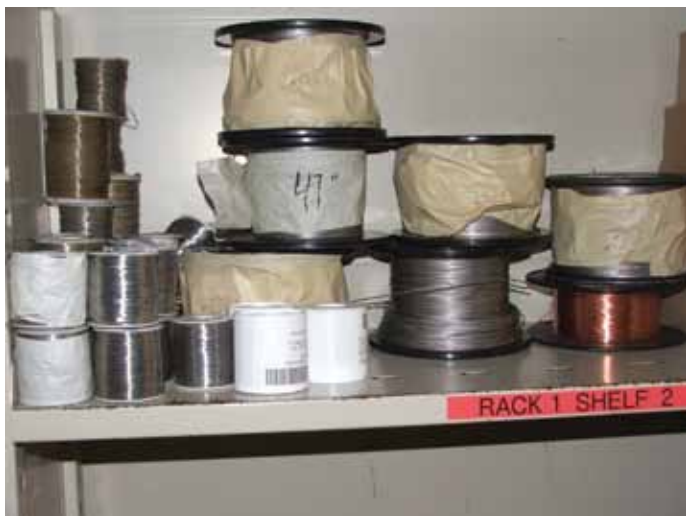
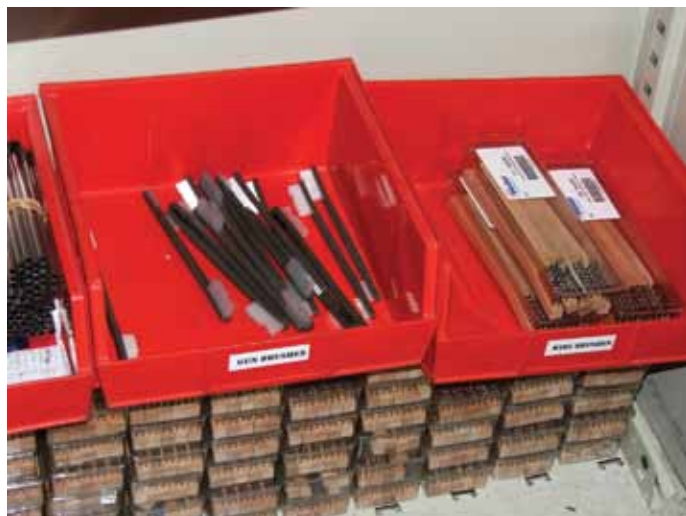
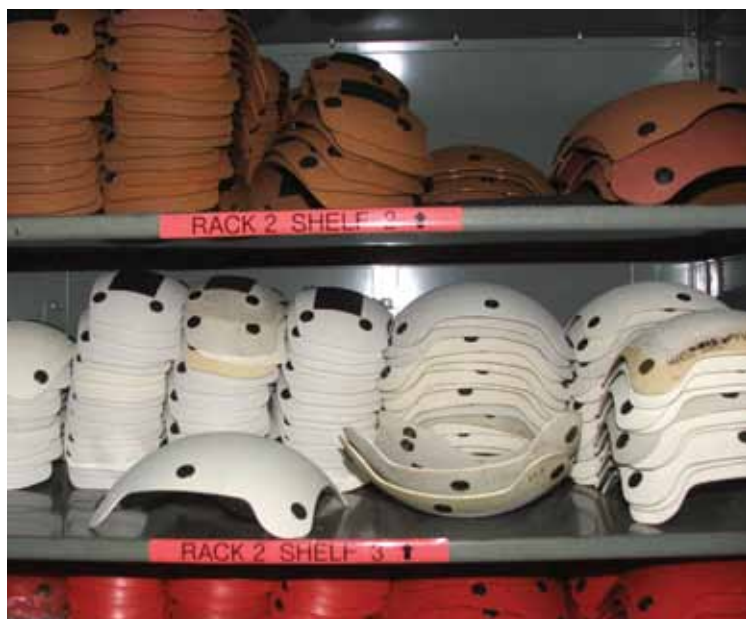
Best Practices: Using your tool logbook, annotate the quantity and name of the consumable items used for each task. It’s also a good idea to store consumables in well-organized lockers and/or shelves (as shown in the enclosed photos). Maintain these storage areas just like you would your pre-ex bin.

Still not convinced? Check out COM-NAVAIRFORINST 4790.2A, Chapter 10, para. 10.12.6.3, which reads: “Ensure consumable materials not included on the tool container inventory, such as safety wire, electrical tape, and acid brushes, are accounted for prior to and at the completion of each task. Tool containers shall not be used for hardware storage.”

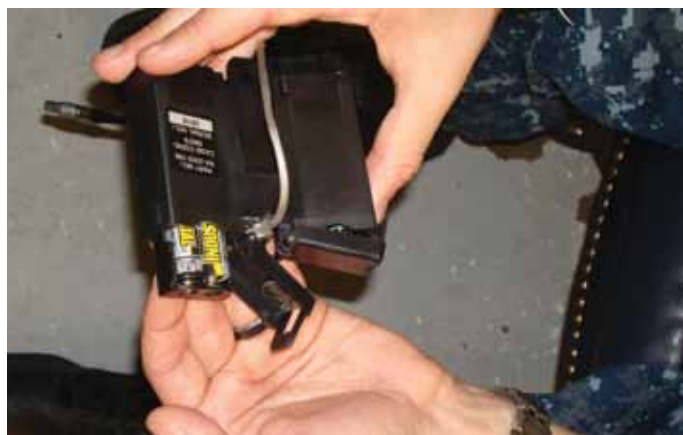
Solution: Follow published guidelines—a responsibility of all hands. Also ensure batteries (and battery-powered equipment) are stored cor-

rectly. For example, in the NAVAIR 16-35AVS9-4 WP 004 00, paragraph 12 requires us to remove batteries from NVG systems after use. Also, in WP 005 00, a caution states, “Never store the AN/AVS-9(V) with the batteries installed.”

If discharged too far, “AA” alkaline batteries start corroding internally. If a battery corrodes enough, the outer shell can breach, causing electrolytes to leak out and damage battery-powered devices. Avoid this problem by removing batteries from devices that are going to be unattended for long periods of time. The electrolytes also can cause minor skin damage, destruction of eye tissue, and severe internal irritation and damage if ingested.

Lithium batteries also are problematic. They produce extremely high currents and can discharge rapidly when short-circuited. The rapid discharge of a lithium battery can cause it to overheat, rupture and even explode.
